Historic Courthouse Renovation Planned Unit Development Phase 1

Site Design Update

Salem Planning Board
Continued Hearing - November 17, 2022

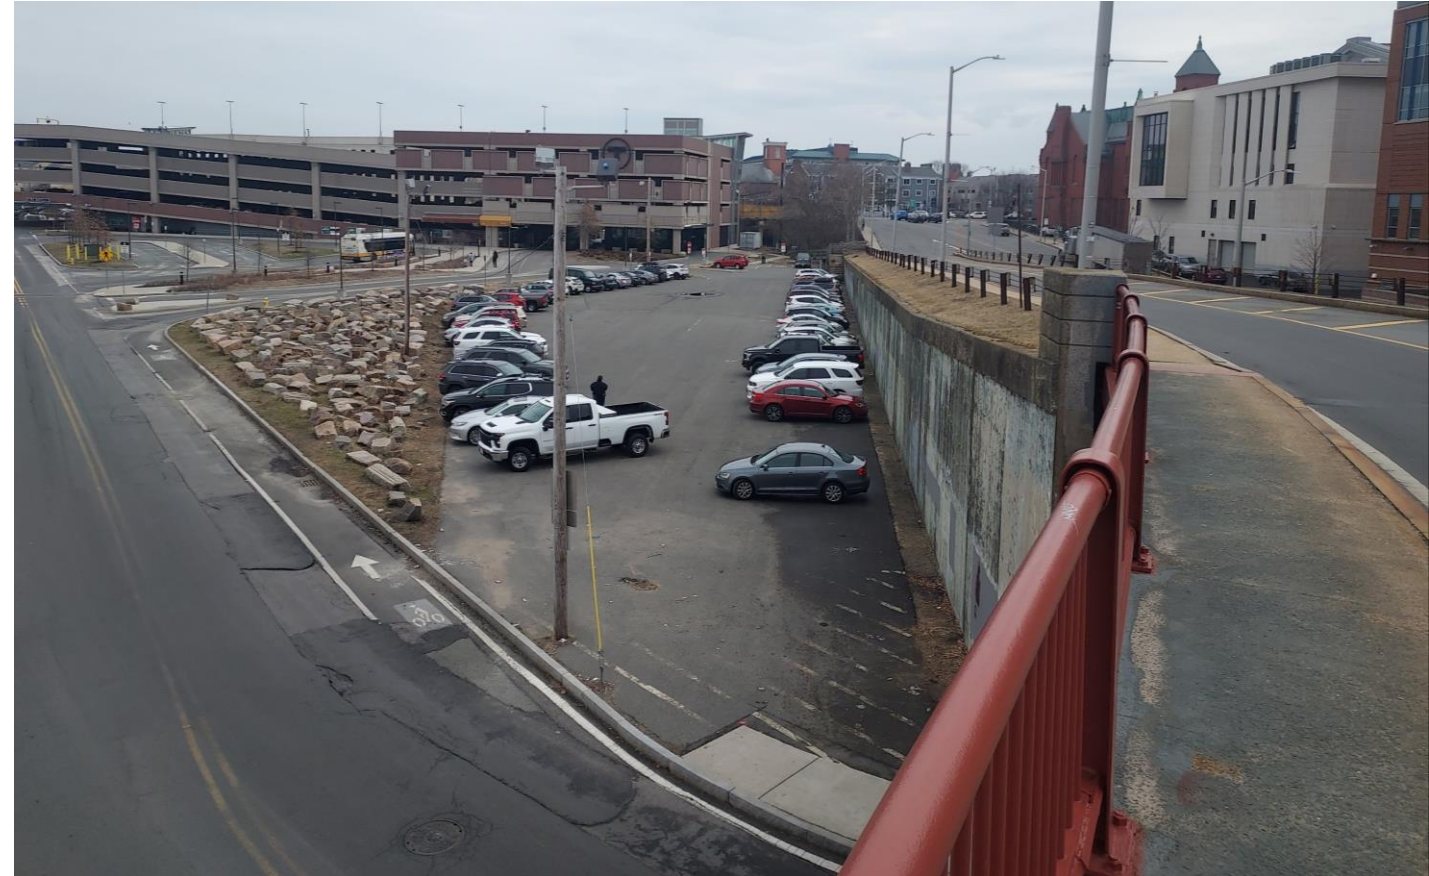
Existing Conditions Summary

- 70 vehicle public parking lot known as the Crescent Lot
- Located in the Central Development (B5) zoning district
- Consists of paved vehicular and pedestrian areas with perimeter landscaping
- Within 100-year floodplain
- Stormwater runoff sheet-flows to northern edge, entering closed drainage system untreated and unmanaged
